Introduction

This discussion will review some of the systemic problems that **guarantee** we have unreliable machines, with plenty of example failures, and offer some ideas and areas of research to potentially improve general reliability.

SSA 2020 Convention OSTIV: Design/Build Reality - Motor-Glider Safety Issues © Dave Nadler 2020 Slide 6

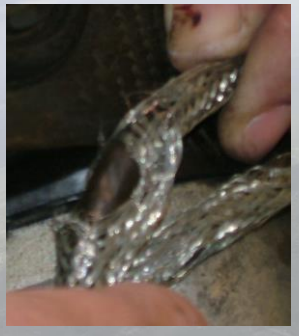
Stupid Fuel Line Tricks

- How about using proper fuel lines?
- Routing/flex management for pylon extension

Many motorgliders have had fuel line leaks or failures:

- Improper material for lines
- Non-fuel fittings
- Chafing
- Crunching/creasing during bending

1) ASW-29ES new 2018
2) Flex line from Nimbus 4DM

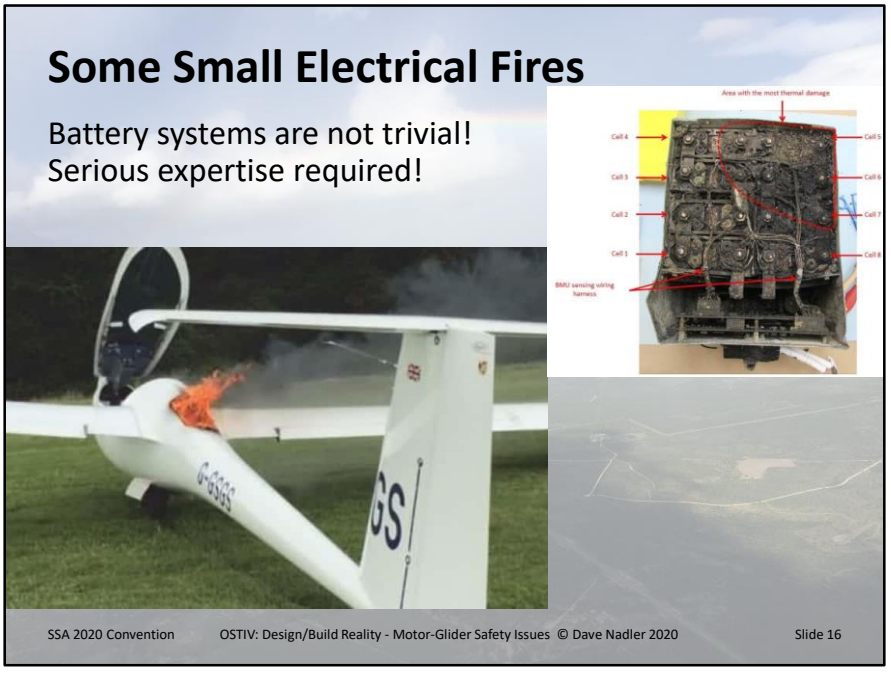
1) A lithium-ion battery that caught fire aboard a parked Boeing 787 in 2013 in Boston had design flaws and it should not have been certified by the U.S. Federal Aviation Administration, U.S. accident investigators said. Boeing 787s were grounded world-wide while this was sorted.

2) 4 FES fires led to battery pack manufacturing and design-safety improvements. No fires since improvements?

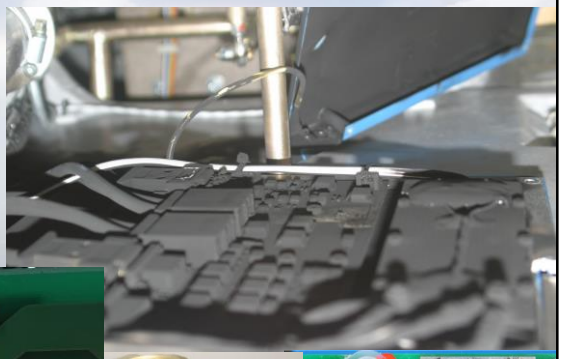
More Electrical Fires

- Lange Antares: hydraulic power supply burned. Proto perf-board! Improper design!
- Lange etc… below.

Discolored epoxy slobber in lower right pictures shows severe overheating.
